# WE (OME IN PIECES + (ONSERVATION PROBLEMS ASSOCIATED WITH THE FUTURO HOUSE AT THE UNIVERSITY OF (ANBERRA

#### John Greenwood

University of Canberra

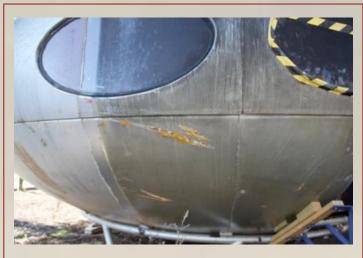
caused during reassembly at UC. There are three holes 20 cm in diameter cut through the base sections, apparently for air conditioning. Other small holes have been drilled into the surface for fittings and there is a series of abrasions, nicks and surface damage to the GRP.

**Figure 4** | Surface abrasions and damage to the GRP caused during transit. Soot staining from the fire.

The outer skin must be made watertight and all of the holes, nicks and other damage will need to be repaired. This will be facilitated by the removal of the

paint layers and stripping back to the gel coat. Tests at the Kroller-Muller Museum in The Netherlands have shown that Araldite 20-20 epoxy adhesive and Miliput epoxy putty are the most effective materials for these repairs (Steiger 2008).

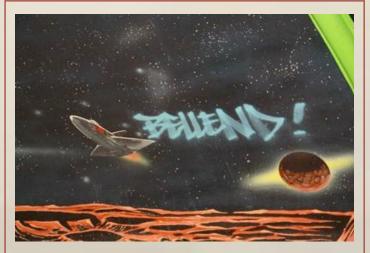
In keeping with its use in an observatory, the interior has been decorated with a space themed mural, which has been defaced by blue spray-painted graffiti. The joins

**Figure 5** | Graffiti damage to the interior space-themed mural.

graffiti will need to be removed and this will be subject to further testing.

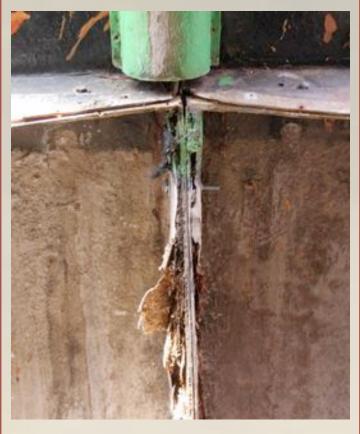
between the flanges have leaked and there is substantial damage to the composite board. This has resulted in the expansion of the composite material,

breakdown of the board and areas of fungal decay. The steel sections forming the floor supports have superficial some corrosion but there is little damage to the structure. There has been some water due ingress to breakdown the rubber window seals.

**Figure 6** | Water damage resulting in swelling and breakdown of composite board on flanges.

The interior has problems emanating from water ingress. The composite board at the joins will need to be consolidated and re compressed. The silicone sealant between the sections has broken down and been damaged and will need replacement. The interior mural will be the subject of a heritage management
