# WE (OME IN PIECES + (ONSERVATION PROBLEMS ASSOCIATED WITH THE FUTURO HOUSE AT THE UNIVERSITY OF (ANBERRA

#### John Greenwood

University of Canberra

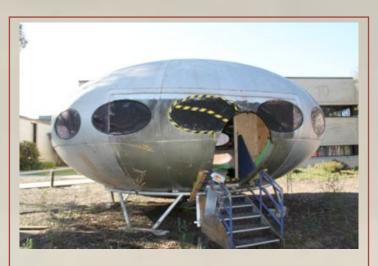
The exterior has some superficial soot and

other surface contamination from the 2010 fire. There are areas of missing paint and small abrasions and some surface damage. These appear to have been

Figure 2 | Futuro at the University of Canberra.

caused during reassembly at UC. There are three holes 20 cm in diameter cut through the base sections, apparently for air conditioning. Other small holes have been drilled into the surface for fittings and there is a series of abrasions, nicks and surface damage to the GRP.
